CE138

Energy efficient historic  
homes – case studies

## Case study 1 Mill Farm, Assington, Suffolk

### Grade II listed farmhouse

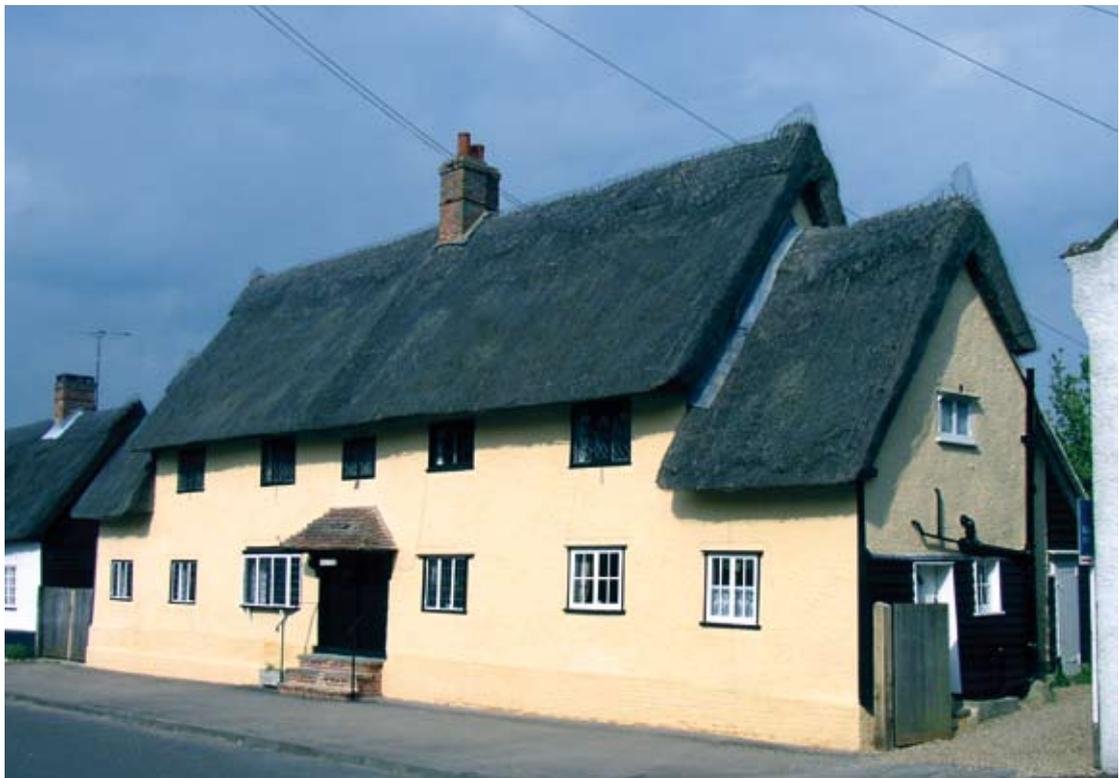
Front elevation of Berg Cottage – upon completion of the works. With limewashed exterior of oak lath

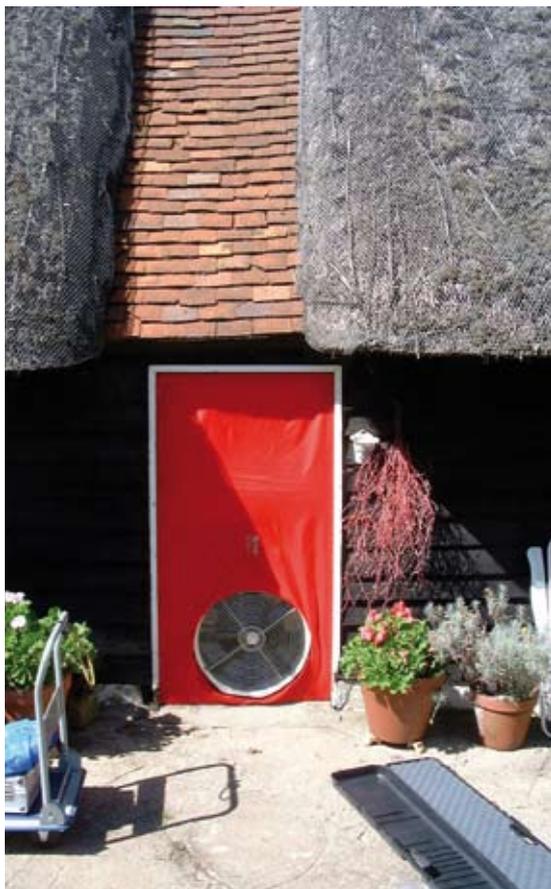
Pressure testing: fan equipment in operation at a doorway on the rear elevation

At Berg Cottage, pressure testing revealed a very draughty 24 air changes per hour. This is much more than necessary to prevent moisture build-up.

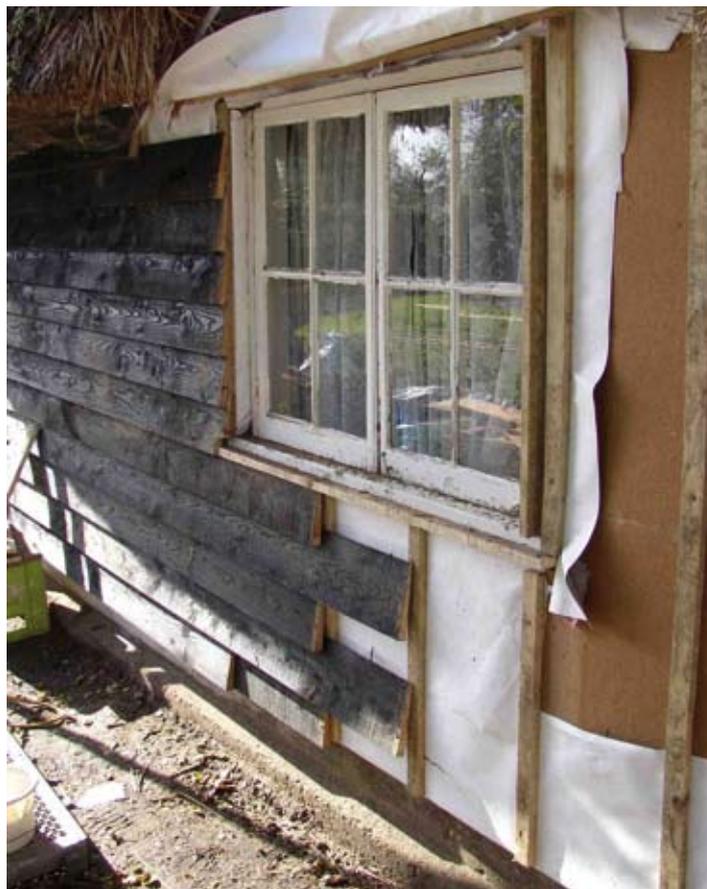
Rear elevation showing works: The woodfibre board can be seen behind the weatherboarding. Junctions are dressed with vapour permeable roofing felt to reduce the risks of draughts

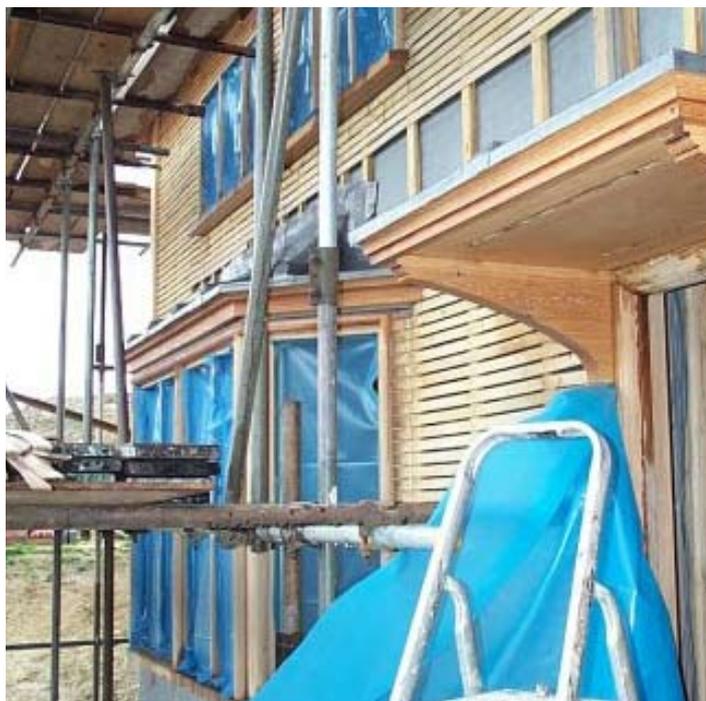
Front elevation of the newly insulated timber frame prior to rendering
